**TARGETED BROWNFIELDS ASSESSMENT
ASBESTOS CONTAINING BUILDING MATERIALS AND
LEAD-BASED PAINT INSPECTIONS**

**Fort Wolters Texas Department of Criminal Justice Property
16.37 Acre Tract at the Southeast Corner of Cross Post Rd. and Grant Rd.
Mineral Wells (Parker County), Texas 76067**

Report Date: October 21, 2010

dse Project N^o : 1037503

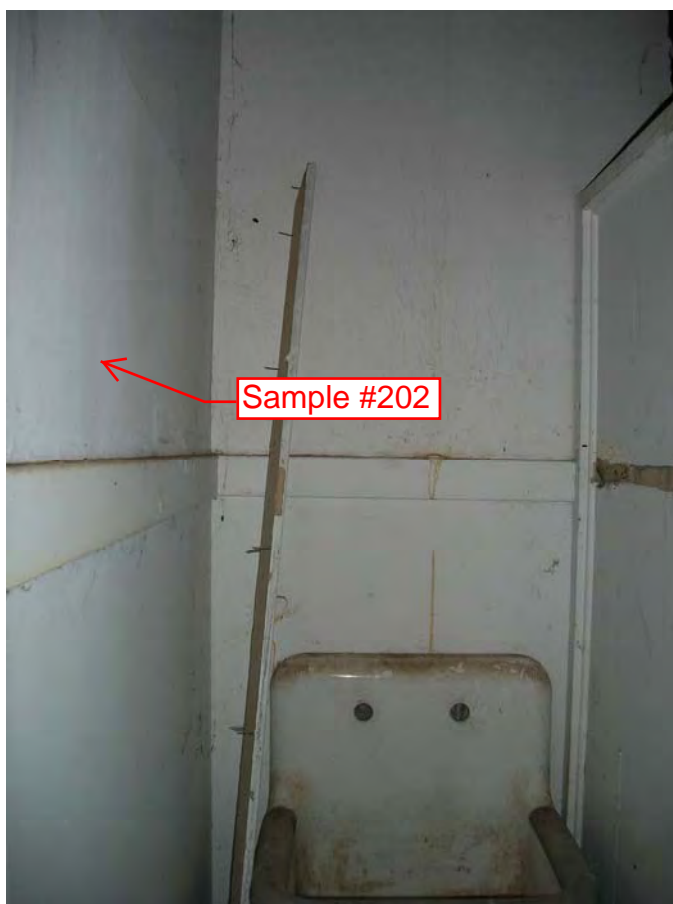
Photo 37 ►

Building 552 - Room 9.

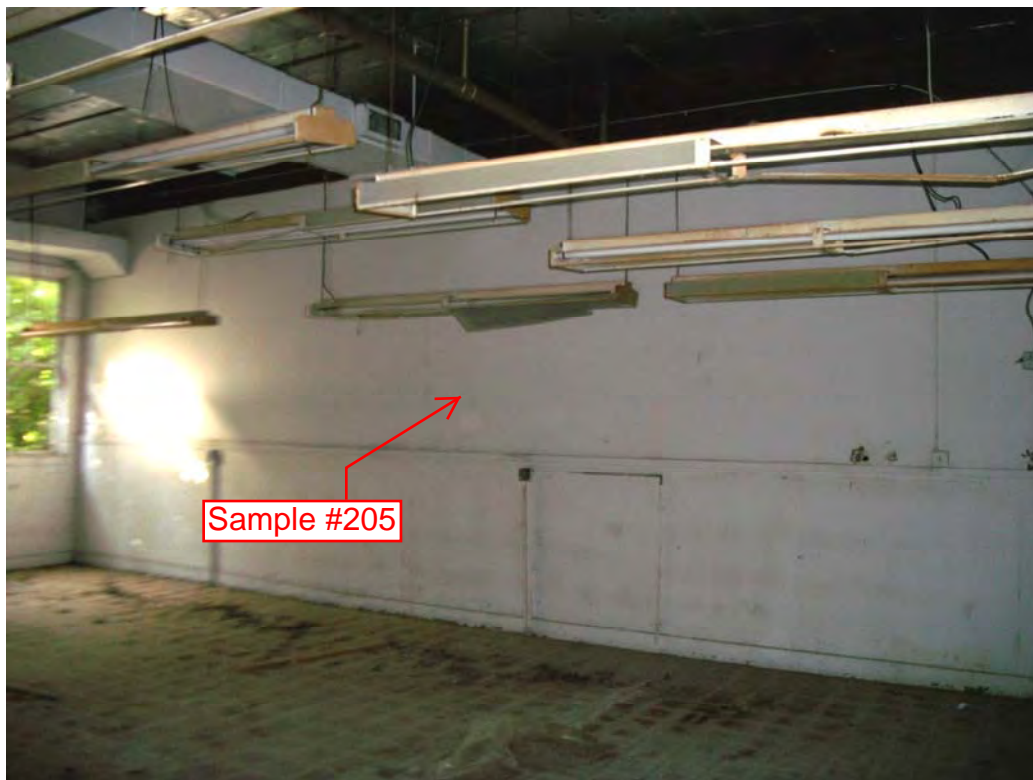
Photo 38 ►

Building 552 - Room 9.

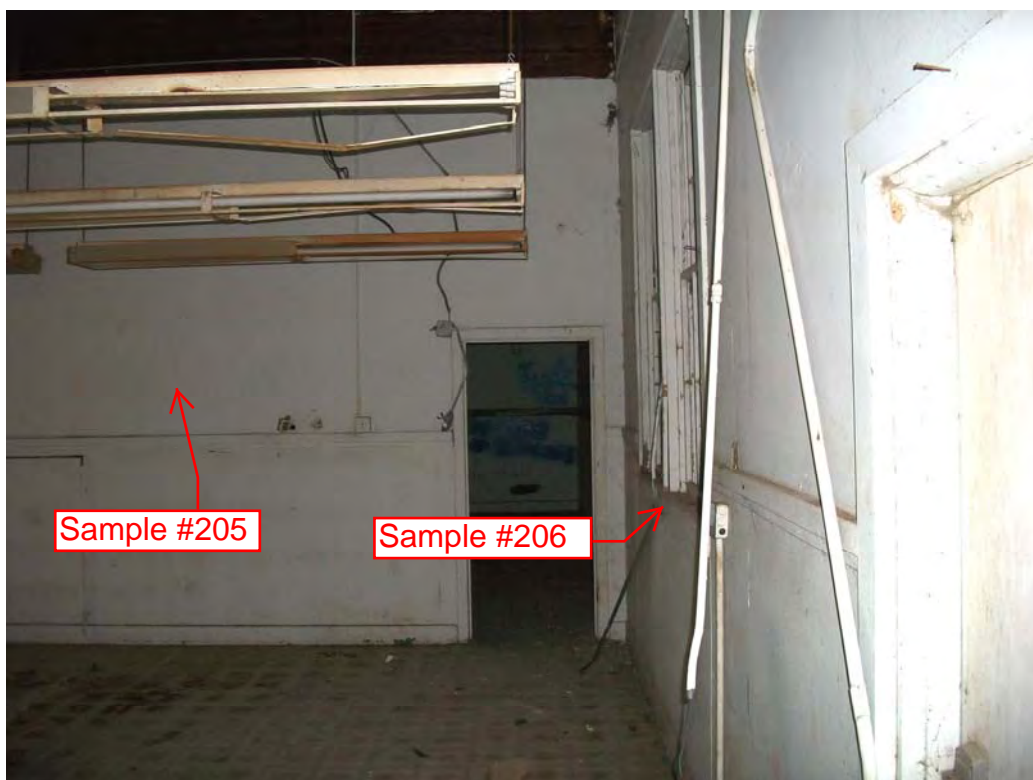
Photo 39 ►

Building 552 - Room 10.

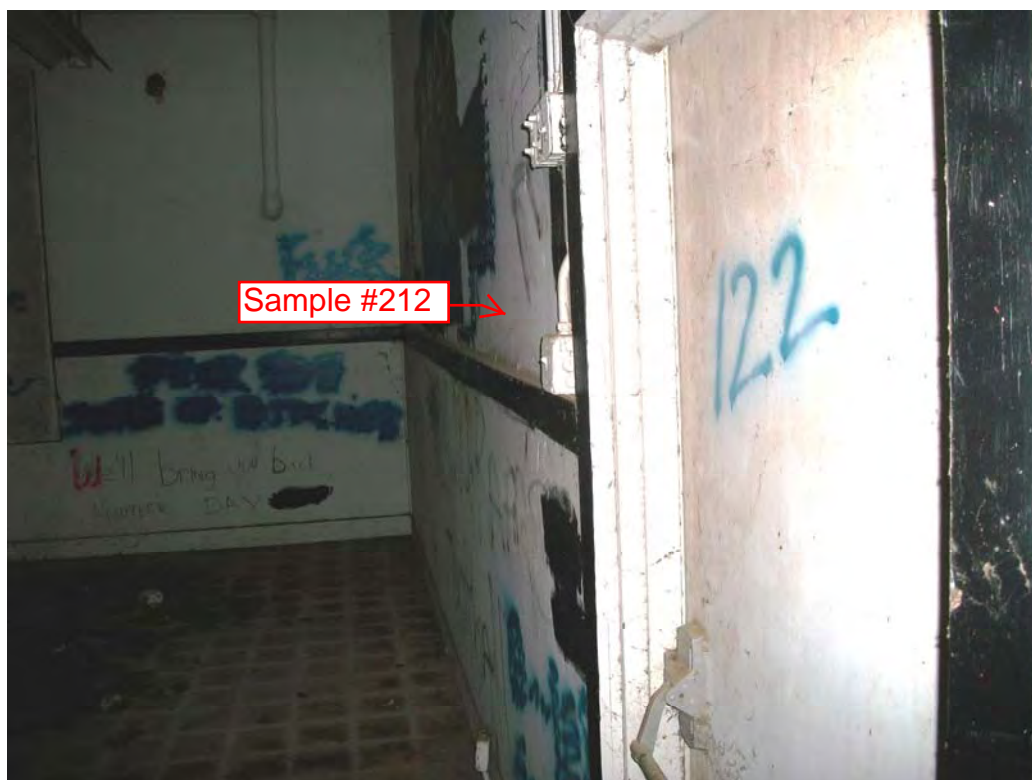
Photo 41 ►

Building 551 - Room 2.

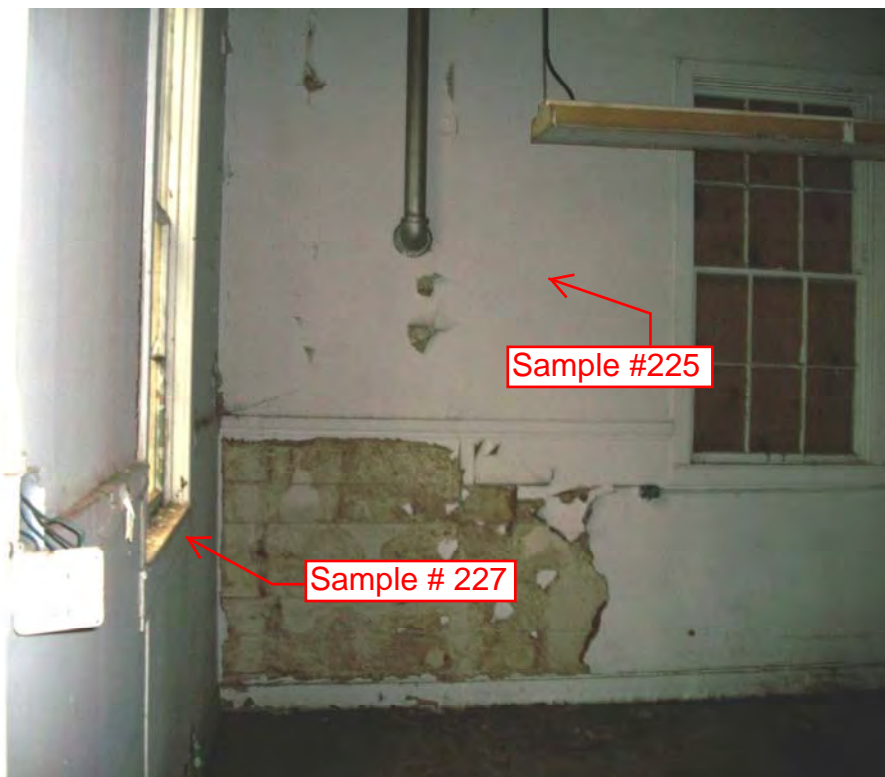
Photo 42 ►

Building 551 - Room 2.

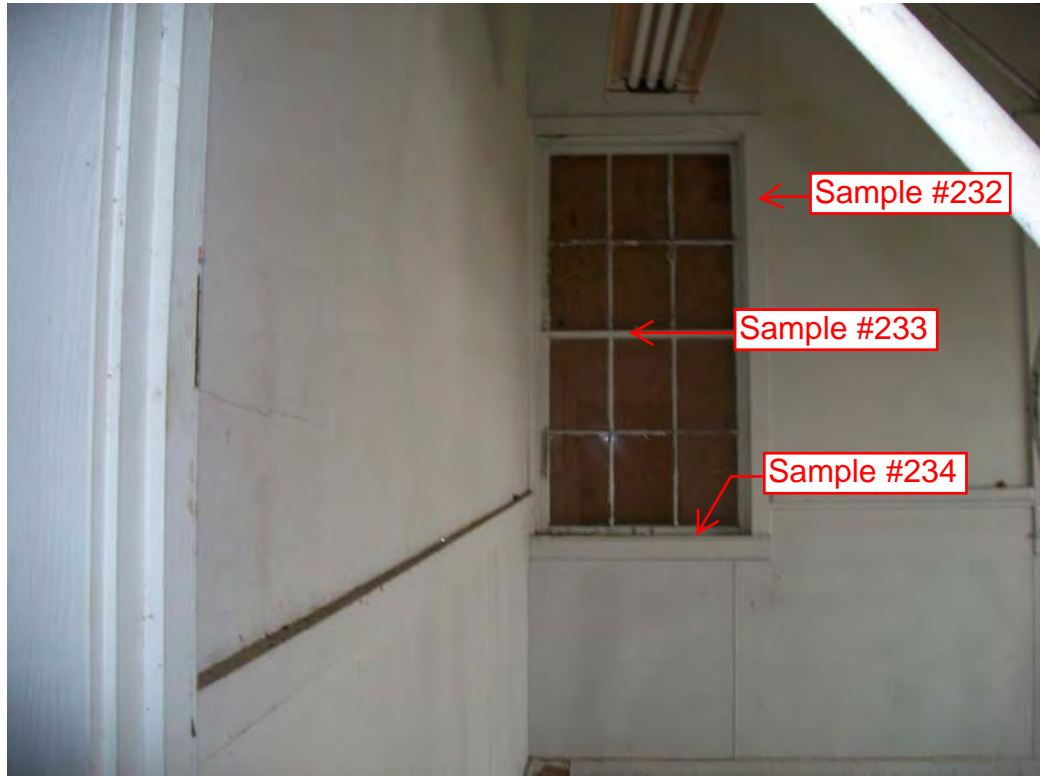
Photo 44 ►

Building 551 - Room 3.

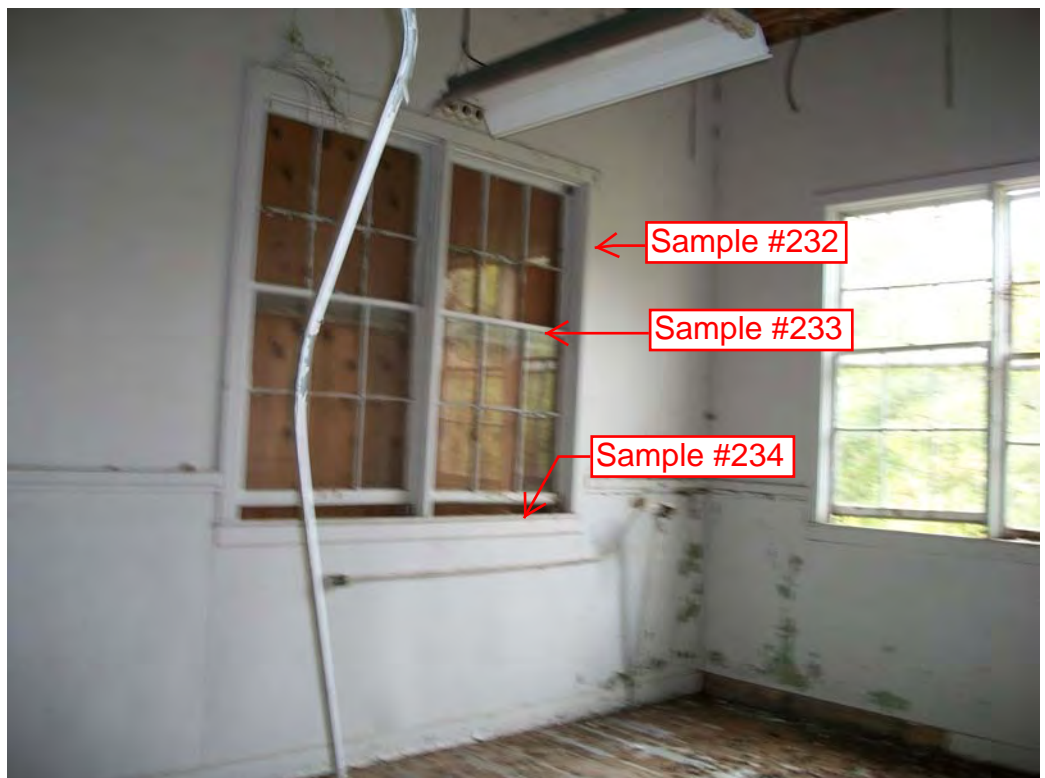
Photo 45 ►

Building 551 - Room 4.

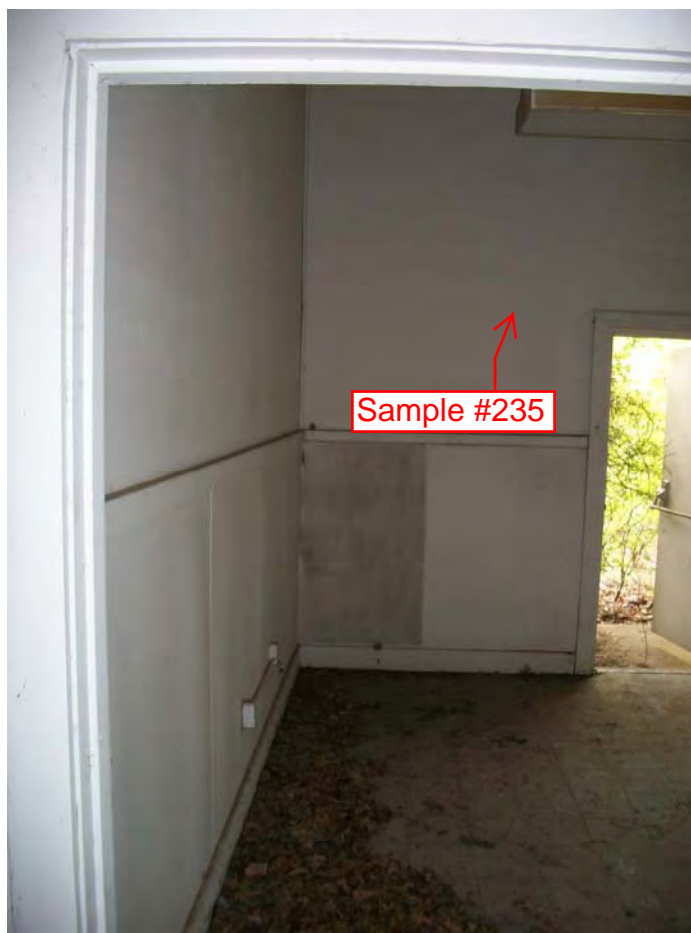
Photo 46 ►

Building 551 - Room 4.

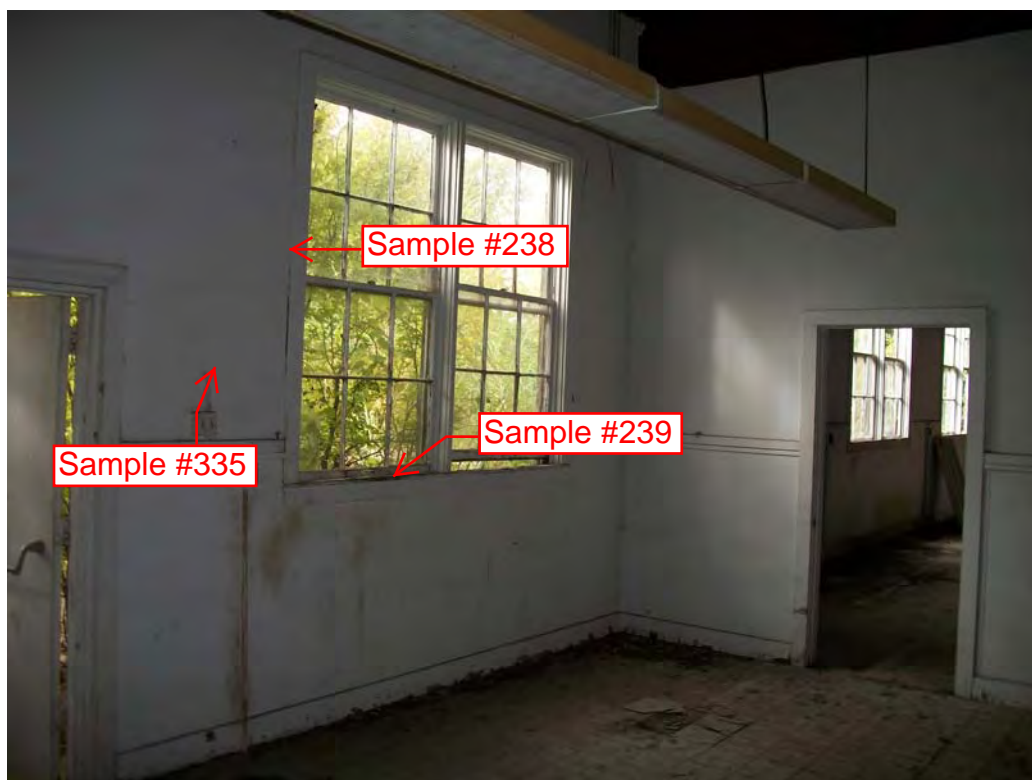
Photo 47 ►

Building 551 - Room 5.

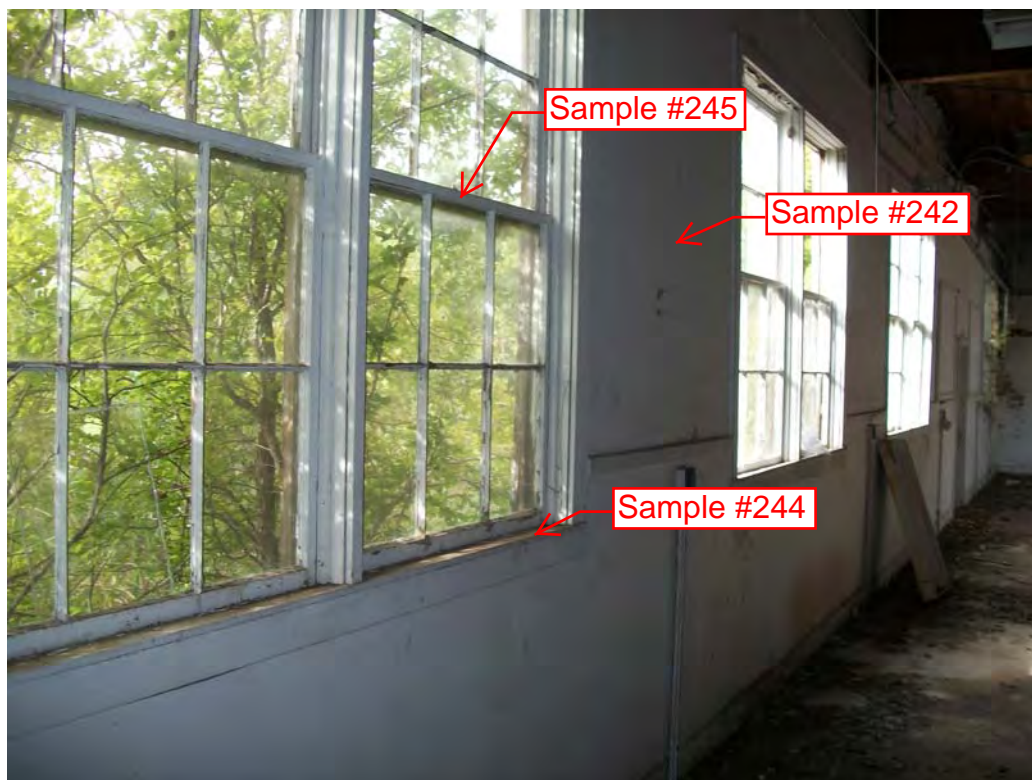
Photo 48 ►

Building 551 - Room 8.

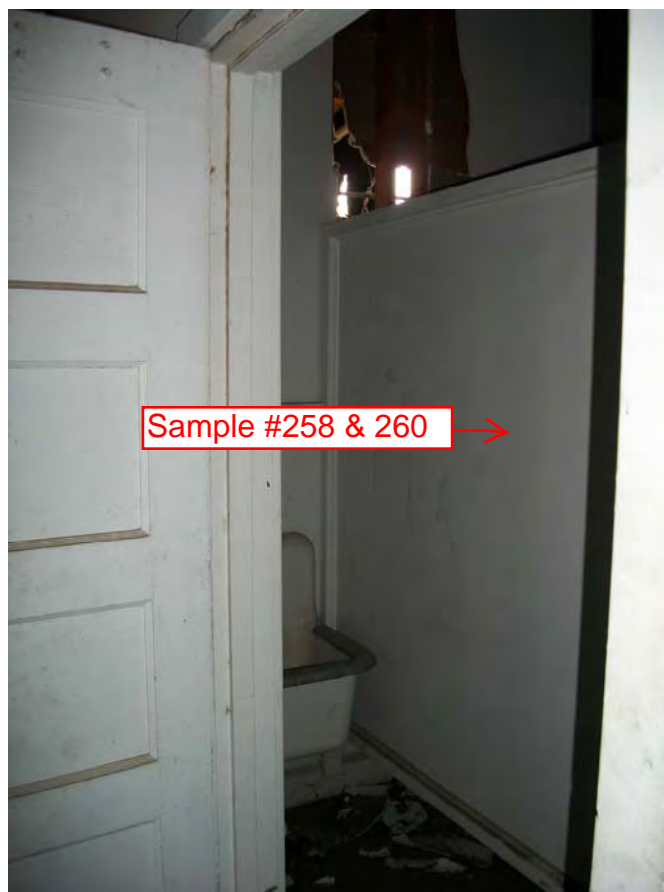
Photo 50 ►

Building 551 - Hallway.

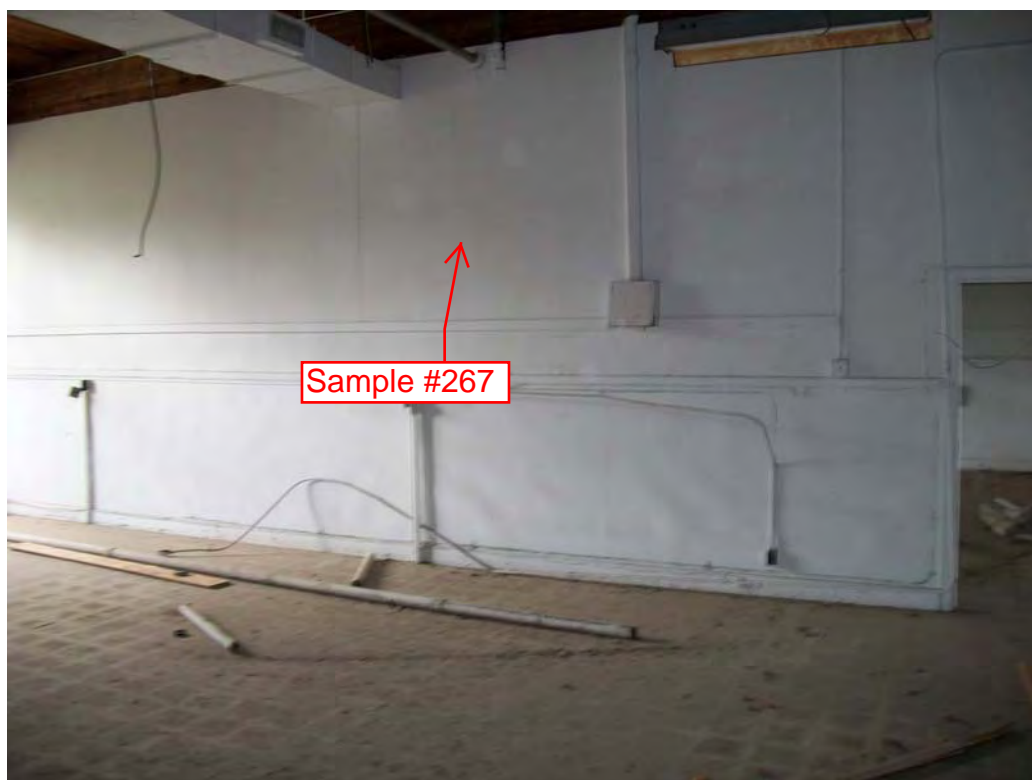
Photo 53 ►

Building 551 - Room 10.

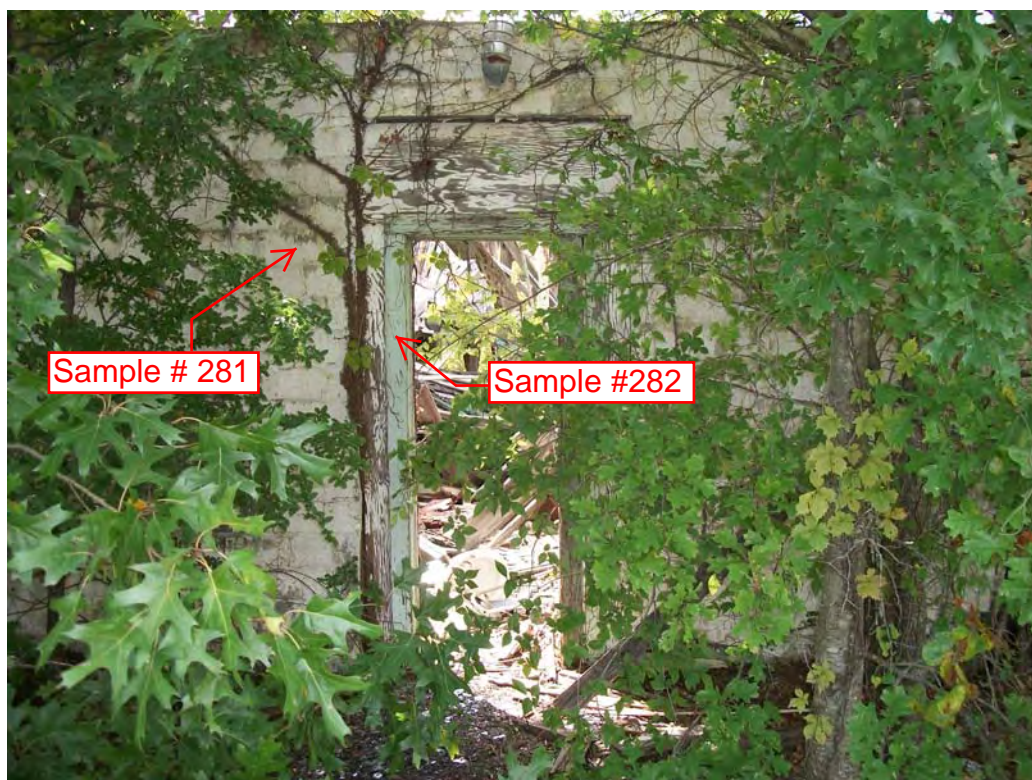
Photo 57 ►

Building 571 - Room 1.

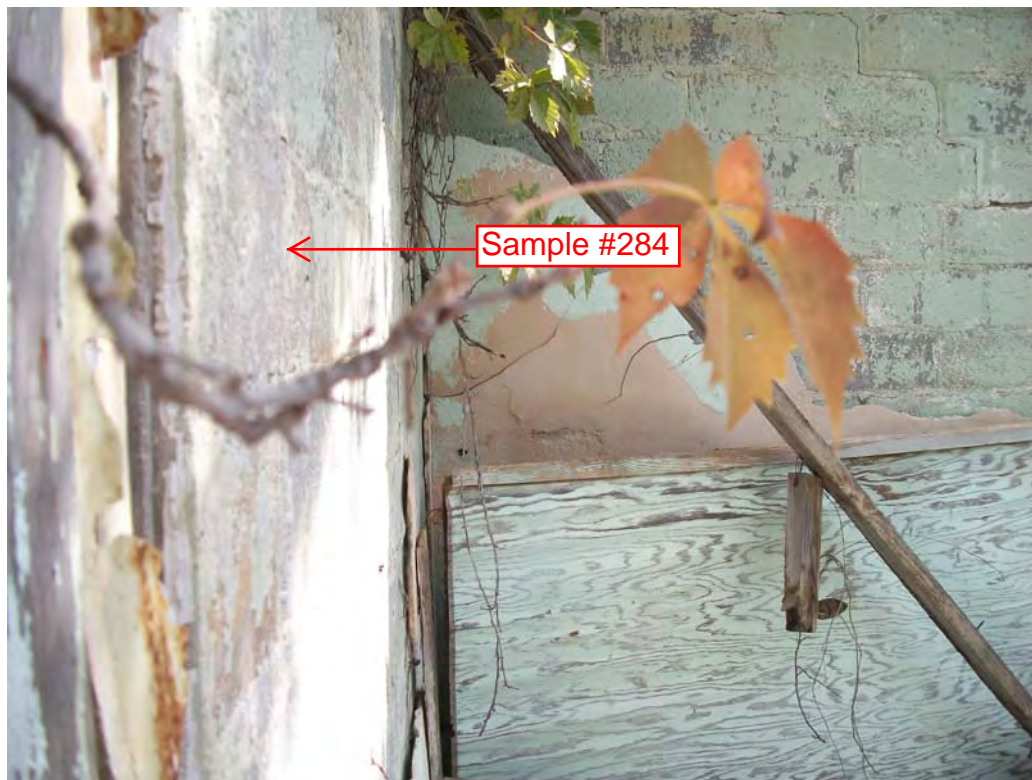
Photo 58 ►

Building 571 - Entrance
to Room 2.

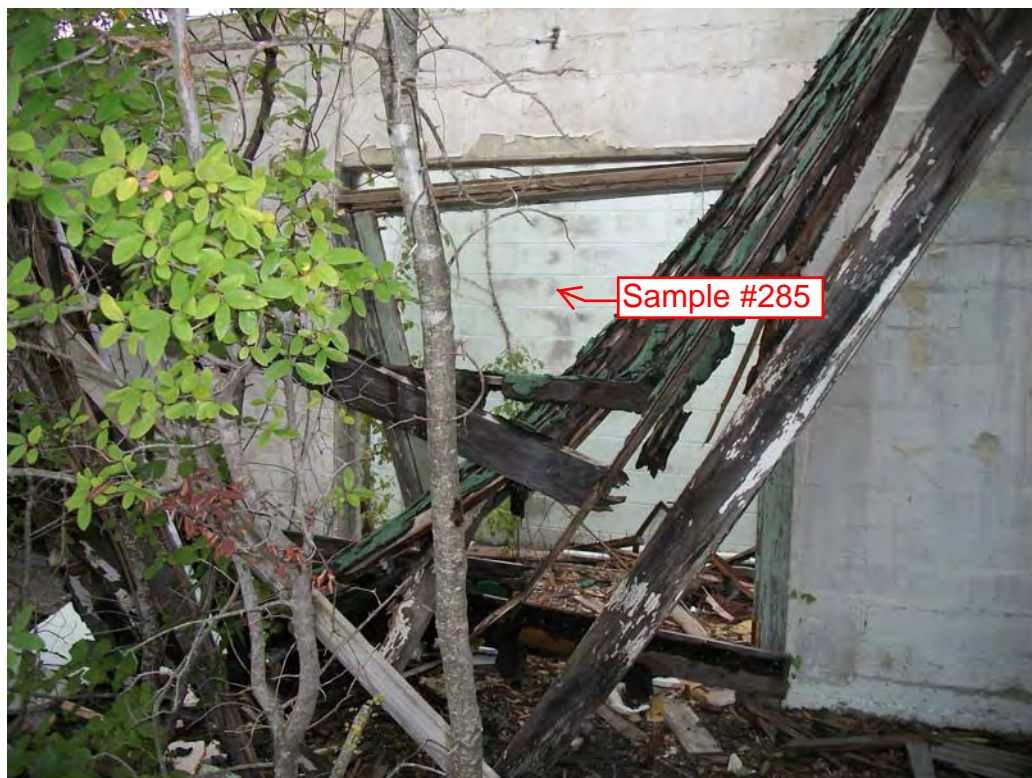
Photo 59 ►

Building 571 - Room 2.

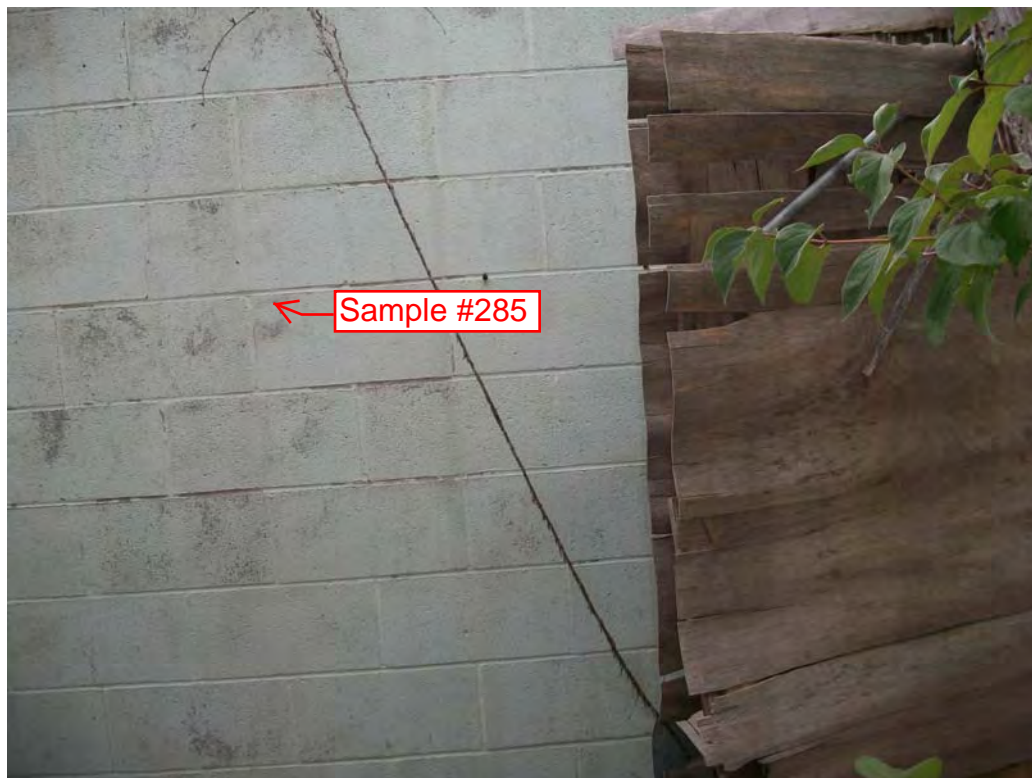
Photo 60 ►

Building 571 - Room 2,
Doorway to Room 3.

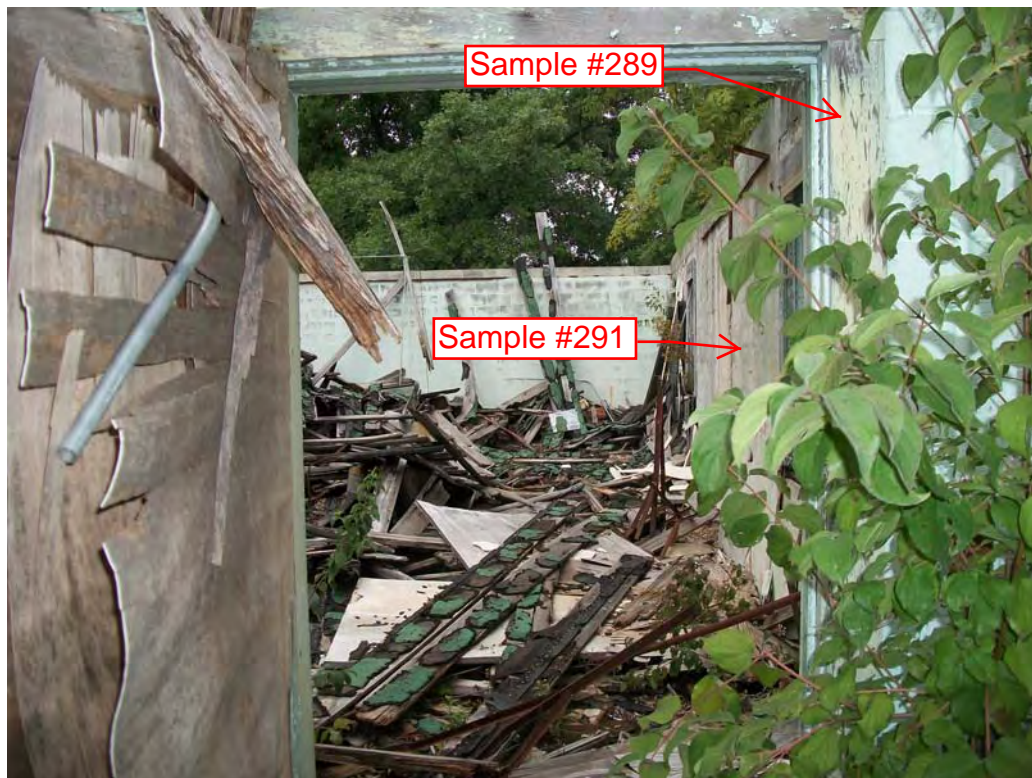
Photo 62 ►

Building 576 - Room 7.
